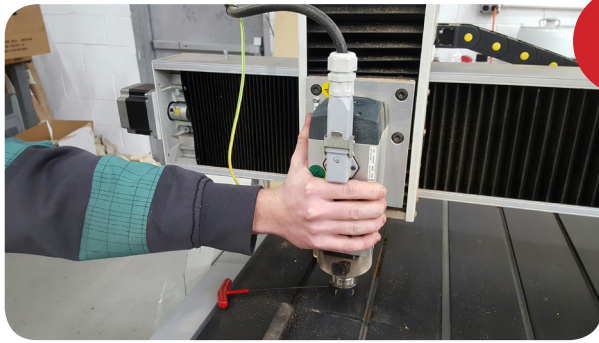
1 To verify there is mechanical backlash, grab the spindle and try and move it right to left. The stepper motor should be under power so that it prevents the screw from turning during this test. Listen for a small banging noise. If a noise is detected, this means the spanner nut may have backed off the ball screw allowing for the ball screw mechanical assembly to move thus causing backlash.

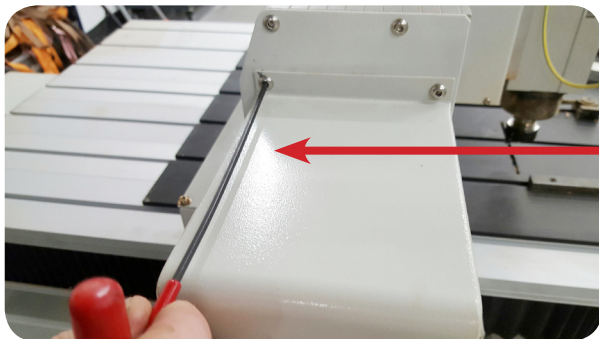
2 Remove stepper motor cover.
NOTE: Two of the screws have hex nuts located by the black bellows covers. Be sure not to lose them when removing cover.

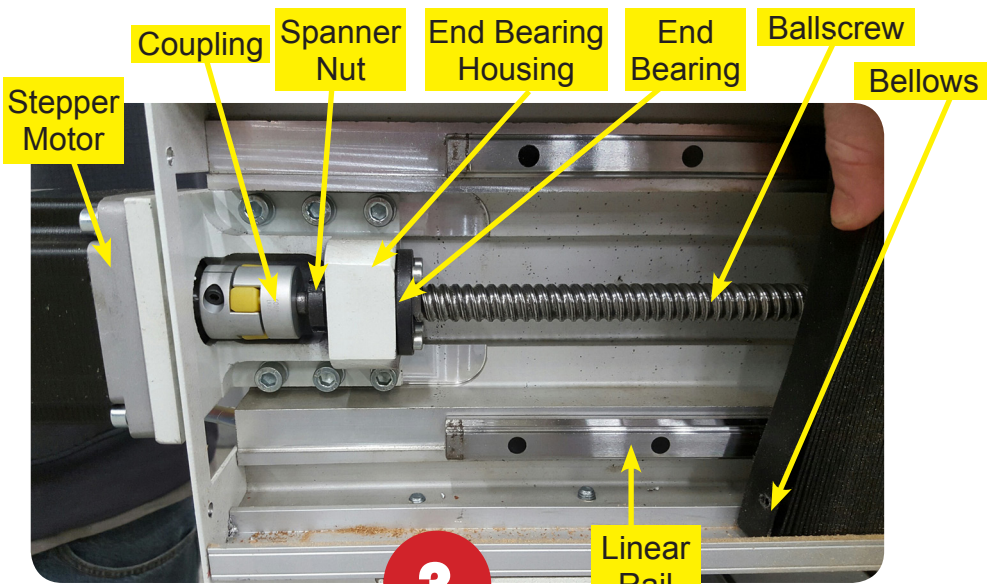
3

Slide back the bellows to expose the end bearing / coupling assembly. Repeat Step 1 and try to visually inspect the spanner nut to see if there is movement or a gap between the spanner nut and end bearing housing. If confirmed there is movement, using a spanner wrench tighten up the nut to remove the backlash. If a spanner wrench is unavailable, a flat head screw driver can be used with a mallet. Place the flat head screw driver blade into the groove of the spanner nut and lightly tap the screw driver tightening the spanner nut. The stepper motor should be engaged to prevent rotation or clamping the coupling to prevent this from turning.

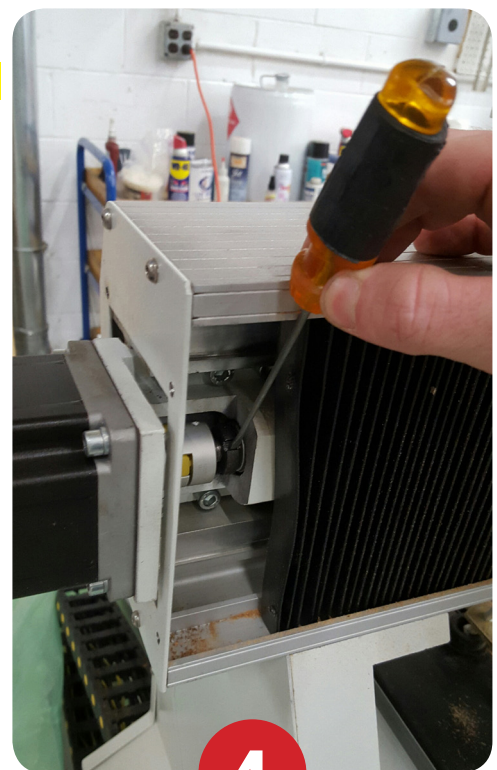
4 After everything is tight, recheck for backlash. If there is minor or no change, repeat the above instructions. In addition, check all fasteners to make sure they are tight and that there is no other movement in the mechanical assembly.
